## SAFETY FLYER TO FISHING INDUSTRY

### Fishing vessel *Pauline Mary* (WY845), fatal man overboard accident, 2 September 2016

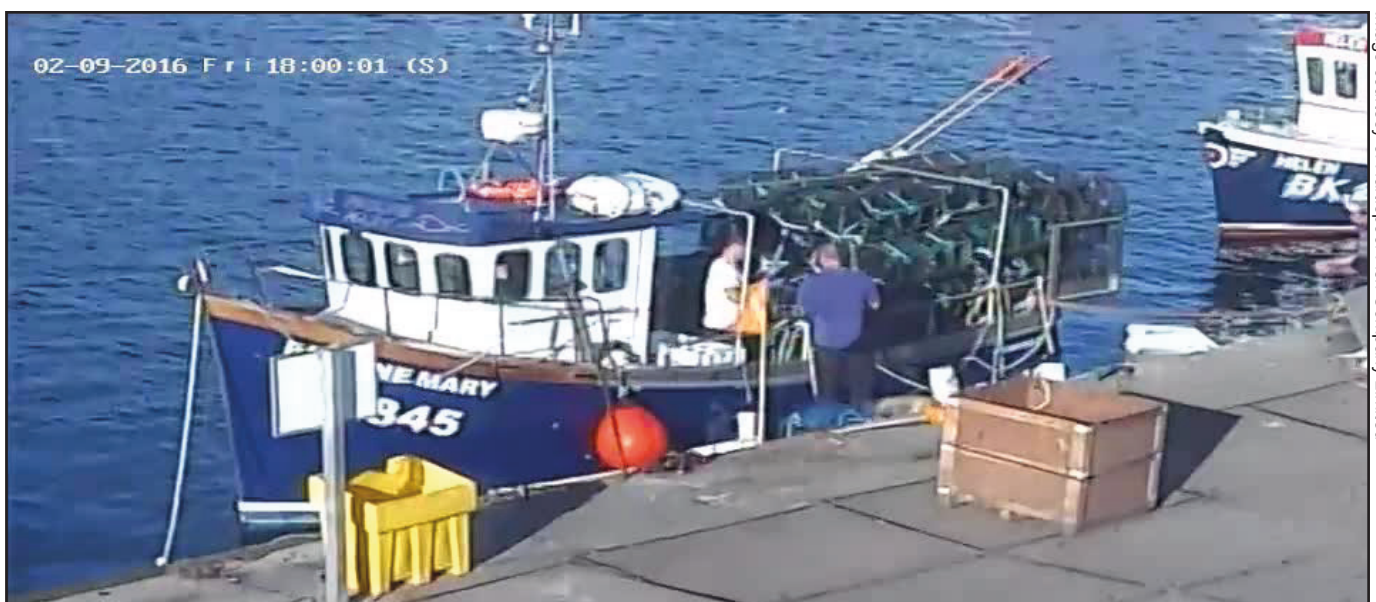
In order to save time during the initial pot laying process, the skipper loaded two strings of 30 pots on board each time he travelled to the fishing grounds. In order to do this, the pots were stacked high on the deck and on the vessel's steel stern rack (**Figure 1**). Similarly, the skipper took his son and his friend to sea during the commercial potting operation because he intended to take advantage of the good weather to enjoy a bit of recreational sea angling once the pots had been laid.

**Figure 1:** *Pauline Mary* alongside Hartlepool Fish Quay prior to sailing showing the pots stacked on deck

The investigation identified that *Pauline Mary* had been heavily loaded with pots and a safe method of shooting them had not been developed. Also, the crewman was not carrying a knife or wearing a personal flotation device (PFD) while working on deck, both of which could have improved his chances of survival. It was also not appropriate for the passengers, in particular a child, to be on board during commercial fishing operations.

On small potting vessels, space can be very limited on the deck; it is important to think about the loading. Given that the fishing grounds were only a short distance from the harbour, it would have been easy to load and then shoot a single string of pots at a time, rather than managing the additional risks of having two strings on board at the same time.

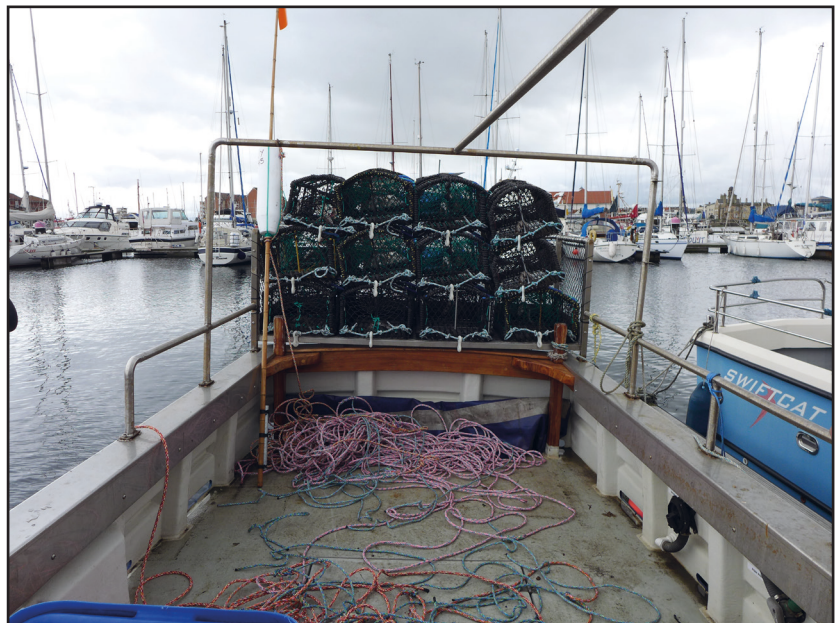
Manually shooting pots from the open deck of a small potter can be extremely hazardous, particularly due to the risk of entanglement in ropes. **Figure 2** is an illustration of the hazard associated with the loose ropes on the deck. In such circumstances, it is vital that a safe system of work is developed, ideally one where the crew and the ropes are physically separated.

**Figure 2:** Illustration of the potential hazard associated with loose ropes on deck

It is important to keep a sharp knife handy at all times. Had the crewman been carrying a knife, or if one had been readily available on deck, there would probably have been an opportunity for the crewman to cut himself free before being pulled overboard.
